CASE STUDY:
BELFAST CITY HOSPITAL

A LOW MAINTENANCE DRAINAGE SOLUTION AT BELFAST CITY HOSPITAL TOWER

HOW GEBERIT'S ELECTROFUSION-WELDED HDPE DRAINAGE PIPES HELPED OVERCOME FREQUENT BLOCKAGES AT BUSY BELFAST HOSPITAL

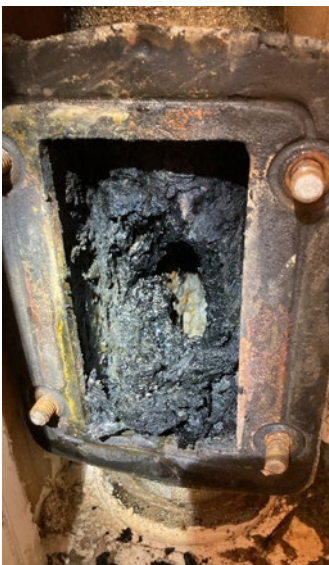
An opened cleaning eye reveals a thick layer of congealed waste inside

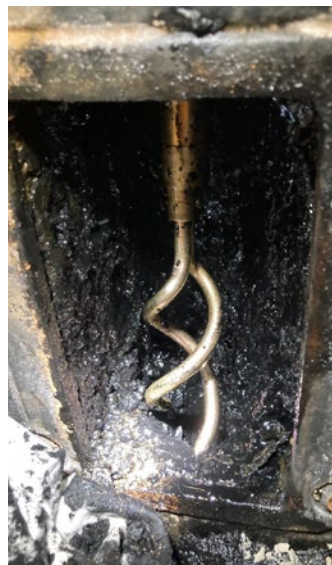
A worm screw pictured through an open cleaning eye as staff attempt to clear a blockage

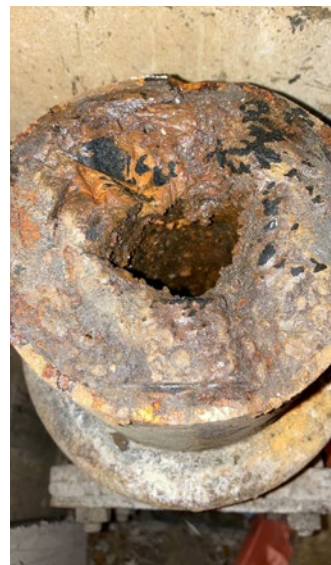
The BCH maintenance team found that a thick layer of congealed waste was causing the majority of these issues by reducing the bore of the 4 inch soil stacks to just over an inch in some places. Sewer rods with a variety of cleaning attachments were used to clear blockages, however much of the congealed layer could not be removed easily. The cast iron pipes, now over 40 years old, were heavily corroded in places leaving a delicate pipe wall. The team knew that excessive mechanical cleaning could damage pipe walls and cause major flooding and escape of contaminated waste to clinical areas. A long-term solution was required.

Congealed waste had reduced the bore of the 4-inch soil stacks to just over an inch in some places

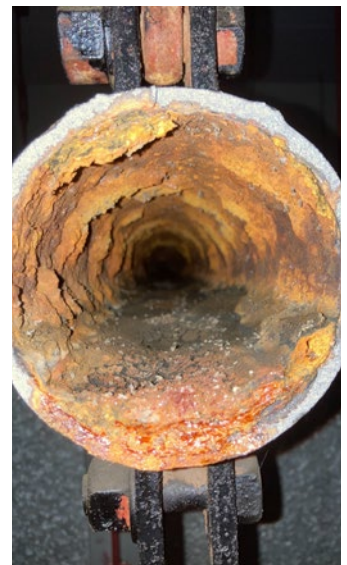
A cutaway image showing internal narrowing at a horizontal section at the bottom of a soil stack

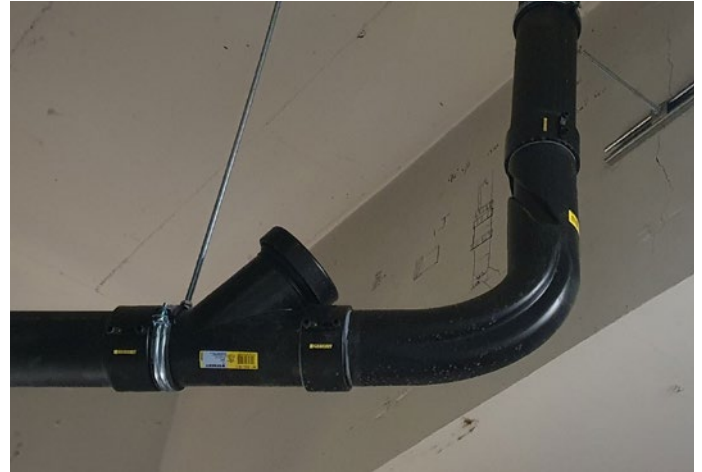
A Geberit HDPE bottom bend

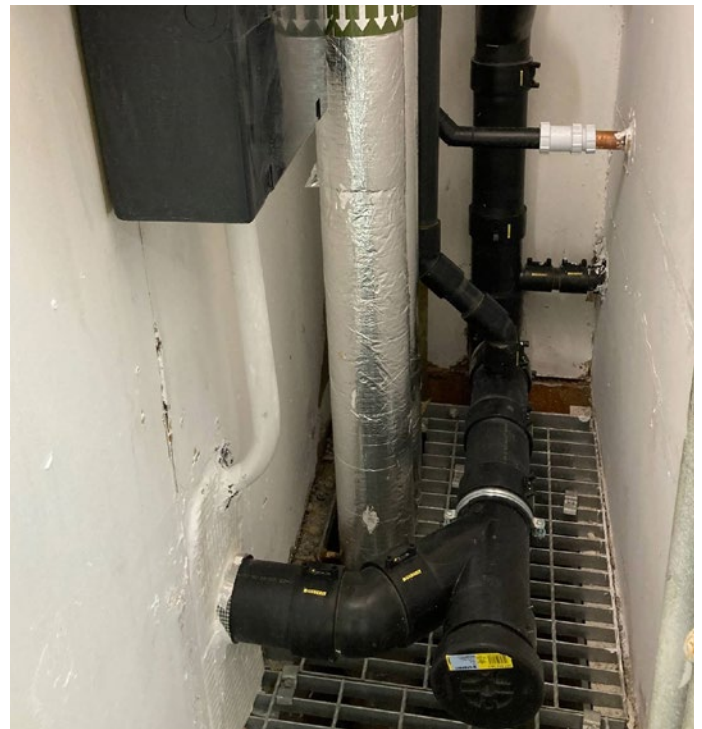
A cleaning access point at the bottom of a new Geberit HDPE soil stack
